**Japan-Nepal Urgent Collaborative Projects  
Regarding the April 2015 Nepal earthquake within the J-RAPID Program**

- 1 . Title of the Project : Identification of temporary evacuation sites and relocation of dangerous settlements in the Dolakha District: an approach by hazard mapping
- 2 . Research/Investigation Period : 2014. 9~2016. 6
- 3 . Amount of Funding : JPY
- 4 . Main Investigators :

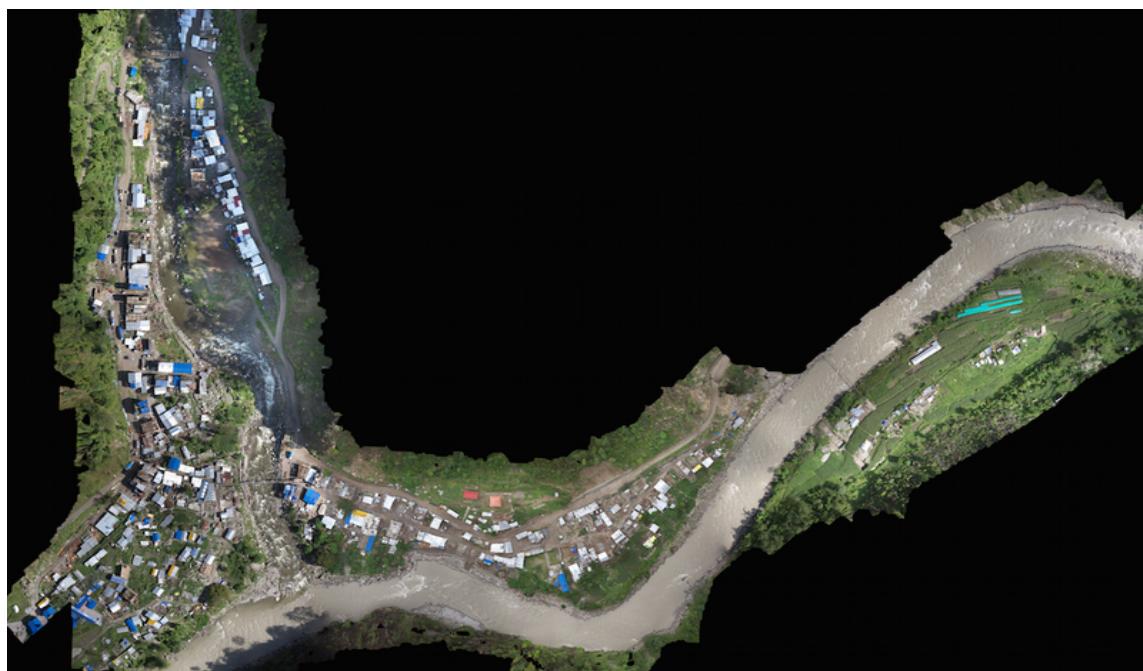
Fig. 2 Orthophotograph prepared by 869 photographs taken by a drone in Shingati.

Photographs were taken by a drone in Shingati and Gongar. In the case of Shingati, 869 photographs were analyzed by software, Photoscan to produce an orthophotograph (Fig. 2). This product has the 3-dimensional topography information, so that land surface analyses such as relationship between the inundation areas and surface topography became possible. Further, the orthophotograph enabled to identify the existing pedestrian routes that can be used for evacuation and to identify safe evacuation sites.

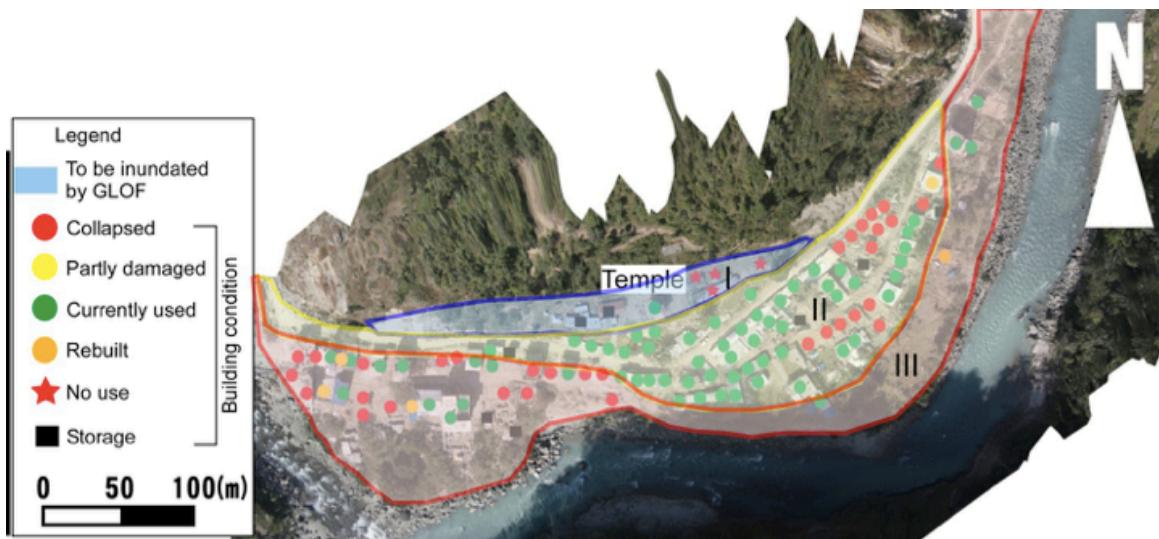
Fig. 3 Distribution of the buildings and the classification of landform of the eastern part of Shingati

The village of Shingati is located on the three river-terrace surfaces (I to III) (Fig. 3). Terrace III, the lowest terrace, has more destroyed buildings, and the existing buildings are most concentrated on terrace II. When Figures 3 and 4 are overlapped, all area of terrace III and part of terrace II would be inundated when GLOF occurs. The houses on these terrace surfaces could be damaged or even washed away.
